Operating Experience Summary

Office of Nuclear and Facility Safety

March 1 — March 10, 2000

Summary 2000-05

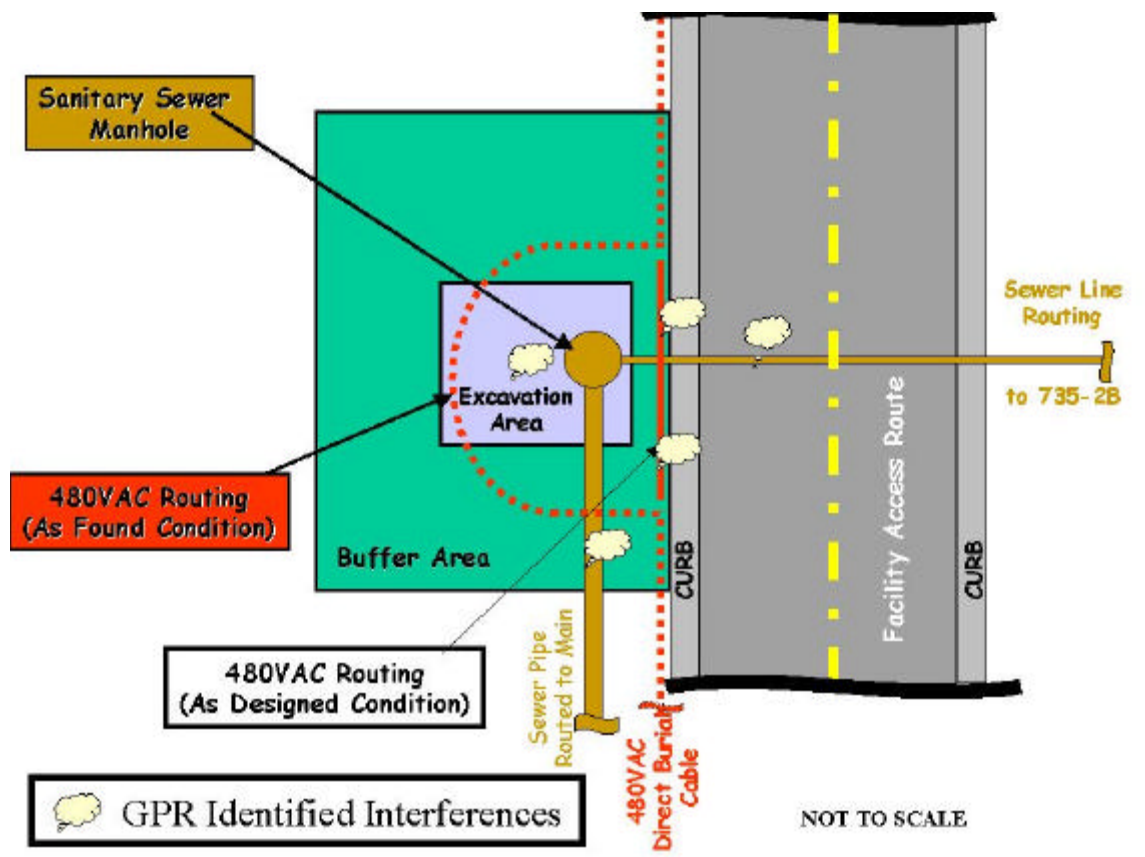
Figure 1-1 Location of re-routed cable

The ground penetrating radar indicated an interference paralleling the curb in the area located on the controlled drawings where the 480-volt electrical line was identified. Sewer lines were also noted both paralleling the road and perpendicular to the road. Another interference was confirmed beside the manhole within the excavation area limits. The contractor initiated hand digging to locate only the interference identified beside the manhole. The other

Local site utilities personnel, brought in after the cut cable was discovered, used a radio frequency signal to confirm the "as found condition" and the "as designed condition" shown on Figure 1-1.

The manhole in the drawing was installed during the original sewer project for the site. Four different subcontracts as well as the facility's own work processes may have been responsible for laying and not recording the location of the subject cable. Investigators suggest a configuration management problem because of a previous cut in this 480-volt line several years ago when another sewer tap was made. The facility contractor apparently cut the cable and repaired the damaged cable by routing the new conductor around the manhole. The contractor apparently made no changes to the site drawings following this work. Excavation for the manhole and subsequent electrical installation excavation made it difficult to see the 480-volt line routed around the manhole, because ground penetrating radar could not see through the disturbed earth and barriers.

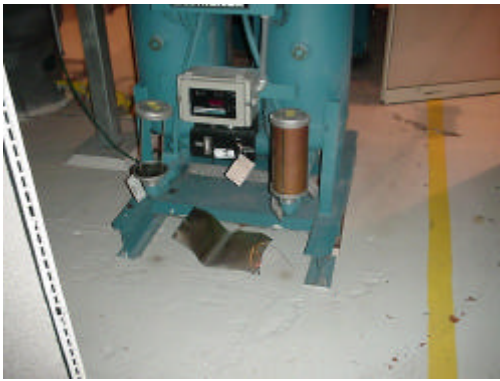
Figure 2-1.
Failed Silencer without Pressure Relief Valve

The failed silencer on the left in Figure 2-1, and the filter with pressure relief, Figure 2-2, are manufactured by Atomuffler. The silencer is a cylindrical device made from treated paper filter media rolled into layers with an outer metal protective shell. The desiccated air inside the unit escapes from the outlet side of the air dryer after passing through the muffling process. Investigators determined that the incoming air picked up desiccating dust, which tended to clog the filter media.

This restricted the flow of air, causing a backpressure on the on-coming purged air, resulting in an “air hammer” effect. The air hammer fatigued the filter media over time, and eventually caused it to fail. The investigators also determined that the failed device was lacking the following design features recommended by the manufacturer:

- Modified Filter Media- lining the inside of the muffler, to capture desiccant fines without significantly impeding the airflow.
- Orifice- provided at the inlet of the silencer, chokes the flow of air, limiting the magnitude of the air delivered and reducing “air hammer” effect.
- Pressure-actuated diversion valve or pressure relief valve, relieving static pressure above 13 psig.

These recommendations could have prevented a build up of excessive pressure in the breathing air system and consequent rupture of the filter media. Investigators discovered that another similar silencer equipped with a spring-loaded pressure relief device, Figure 2-2, performed its function without failure. Provision of a spring-loaded pressure-relief valve prevented air impulse damage on the muffler by diverting excess airflow. Investigators also determined that regular inspections and maintenance of the breathing air system would have helped line management to mitigate conditions contributing to the failure.
